EARTHQUAKES AND BUILDING CONSTRUCTION

A Review of
Authoritative Engineering Data
and Records of
Experience

Published by CLAY PRODUCTS INSTITUTE OF CALIFORNIA
611 Architects Bldg., Los Angeles 116 Natoma Street, San Francisco

COPYRIGHT 1929 BY CLAY PRODUCTS INSTITUTE OF CALIFORNIA

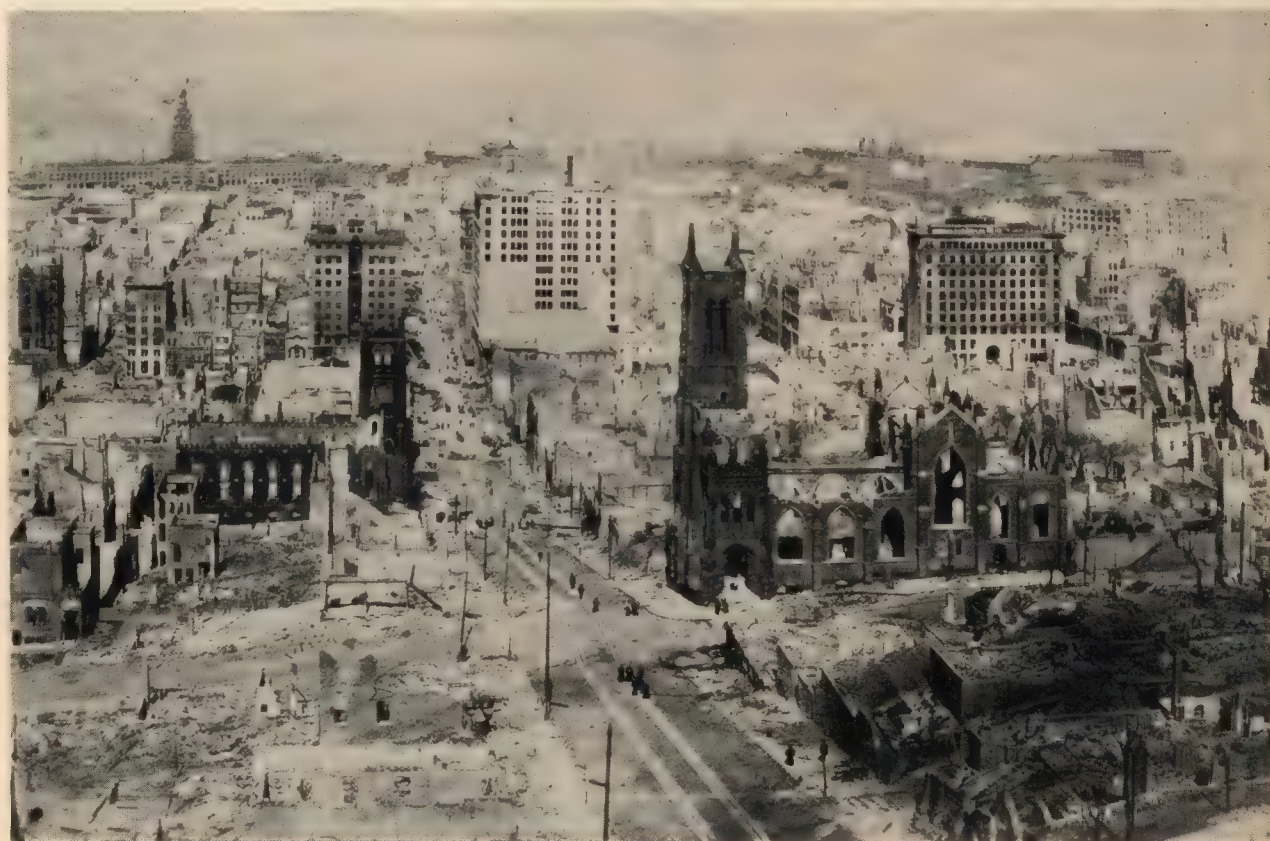
No. 1—San Francisco after the earthquake and fire looking down California Street. Note the brick walls of churches standing intact and brick filler walls in the office buildings in background.

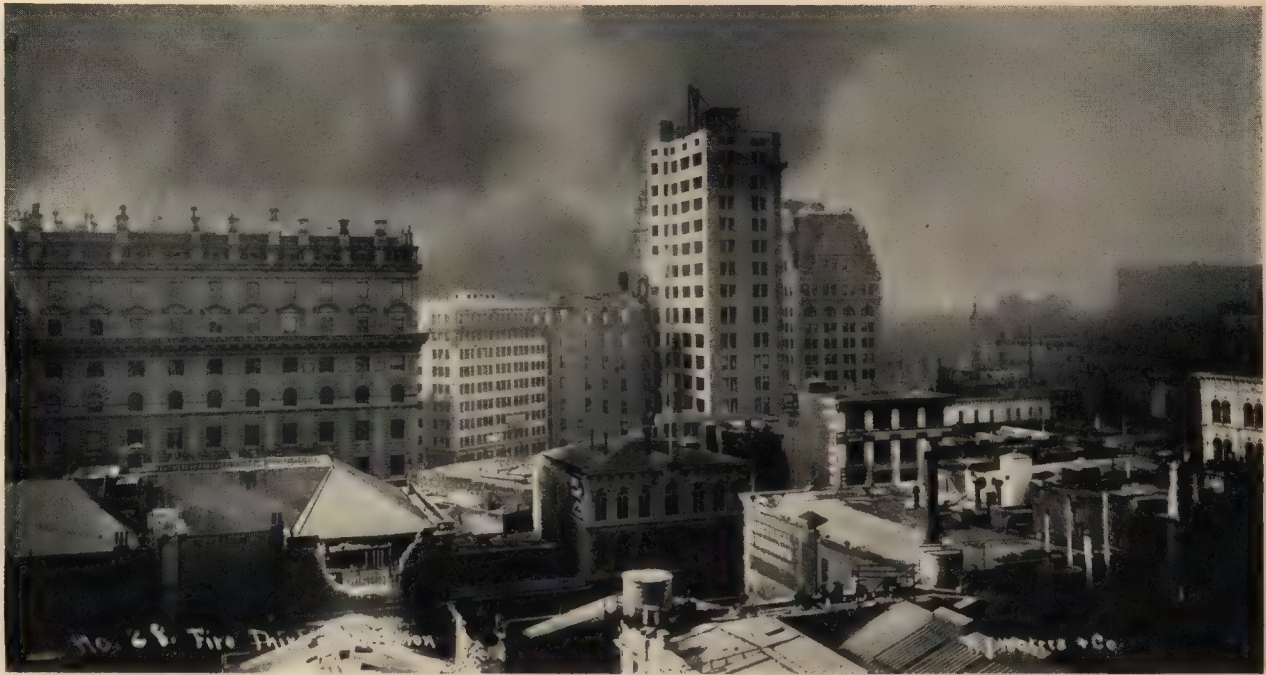
No. 3—Taken between the earthquake and fire. Old and new Chronicle Buildings in center. Mutual Savings Bank at right. Note comparatively intact condition of all buildings shown including practically all chimneys. District later destroyed by fire.

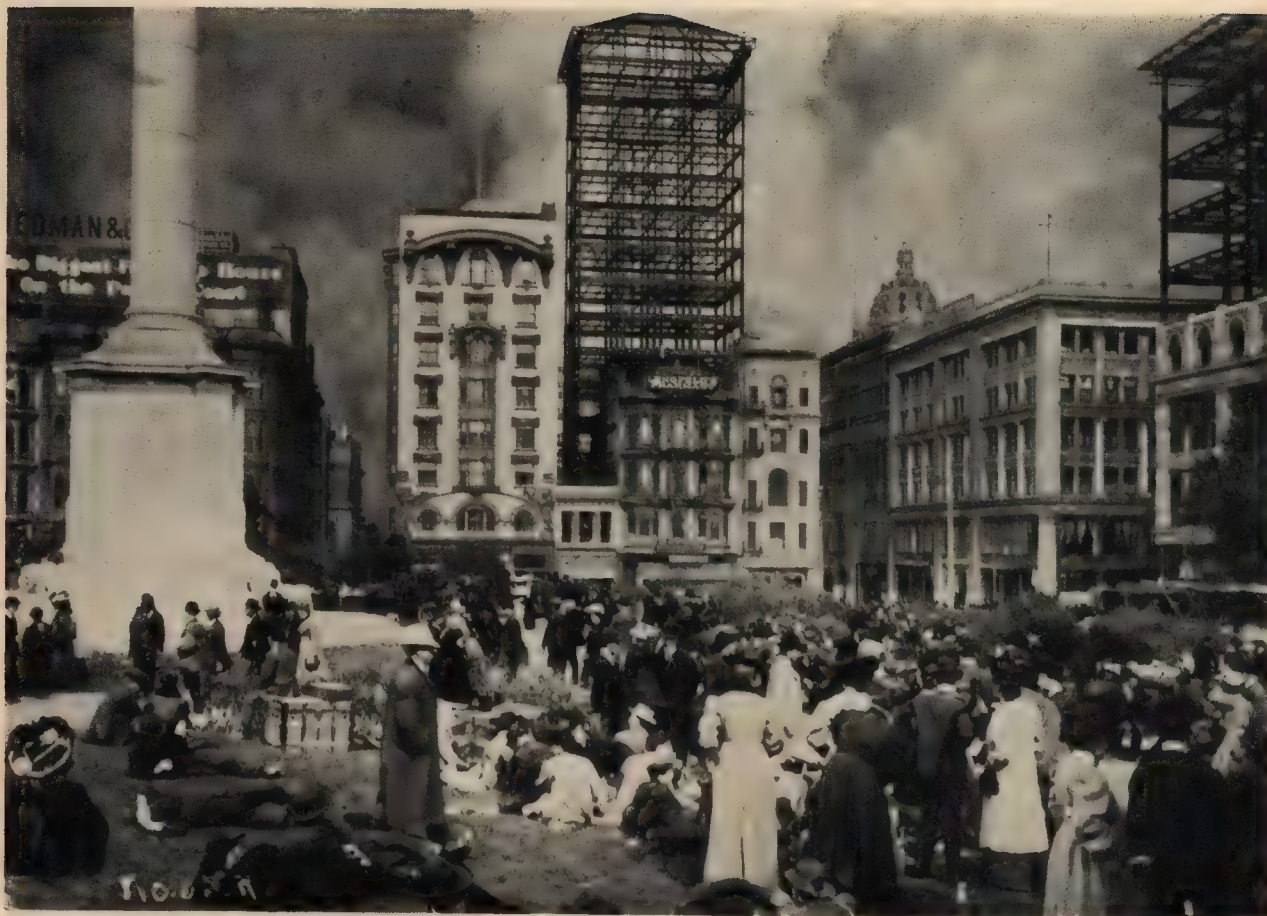
No. 5—Union Square, taken between the earthquake and fire. No sign of earthquake damage. The two structural steel frames were buildings in course of construction, the center being the Whittell Building, and the one on extreme left being Nathan Dohrman Building.

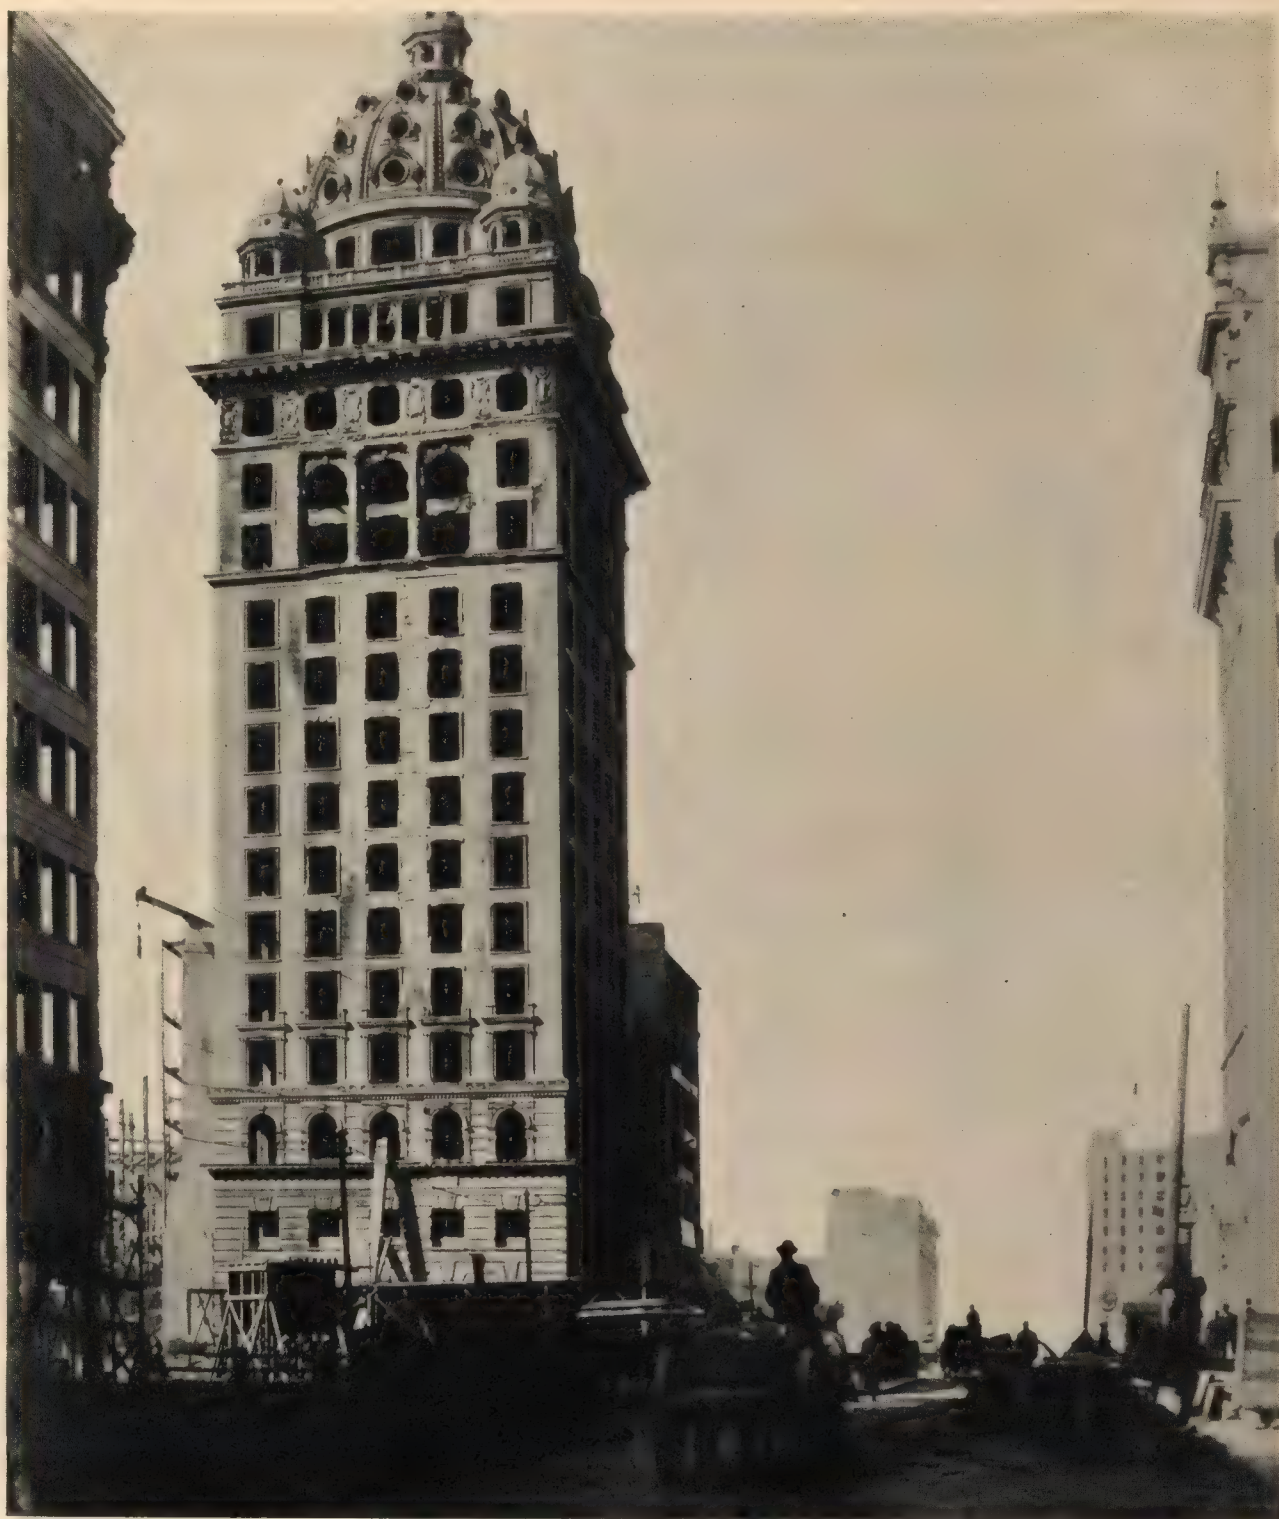
No. 6—The tallest building in San Francisco at the time of the earthquake, the Call Building (now Spreckels Building), Third and Market Streets. Steel frame, brick filler walls and terra cotta trim. Undamaged by the earthquake. In use 1929.

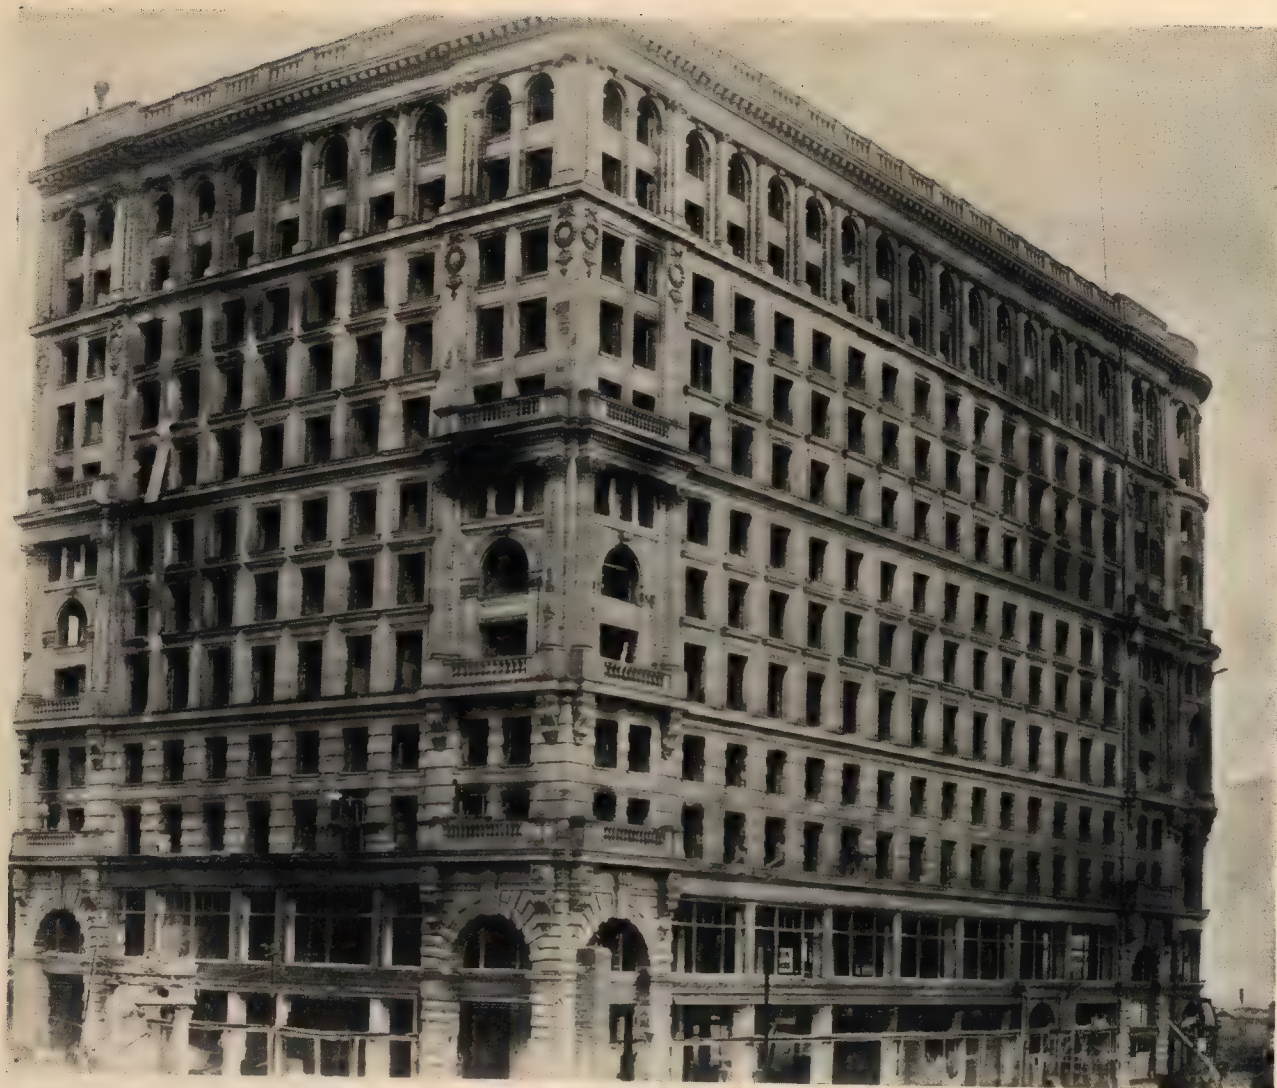
No. 7—Flood Building, 870 Market Street. Steel frame, brick filler walls, granite facing, showing lack of earthquake damage although evidences of burning. In use 1929.

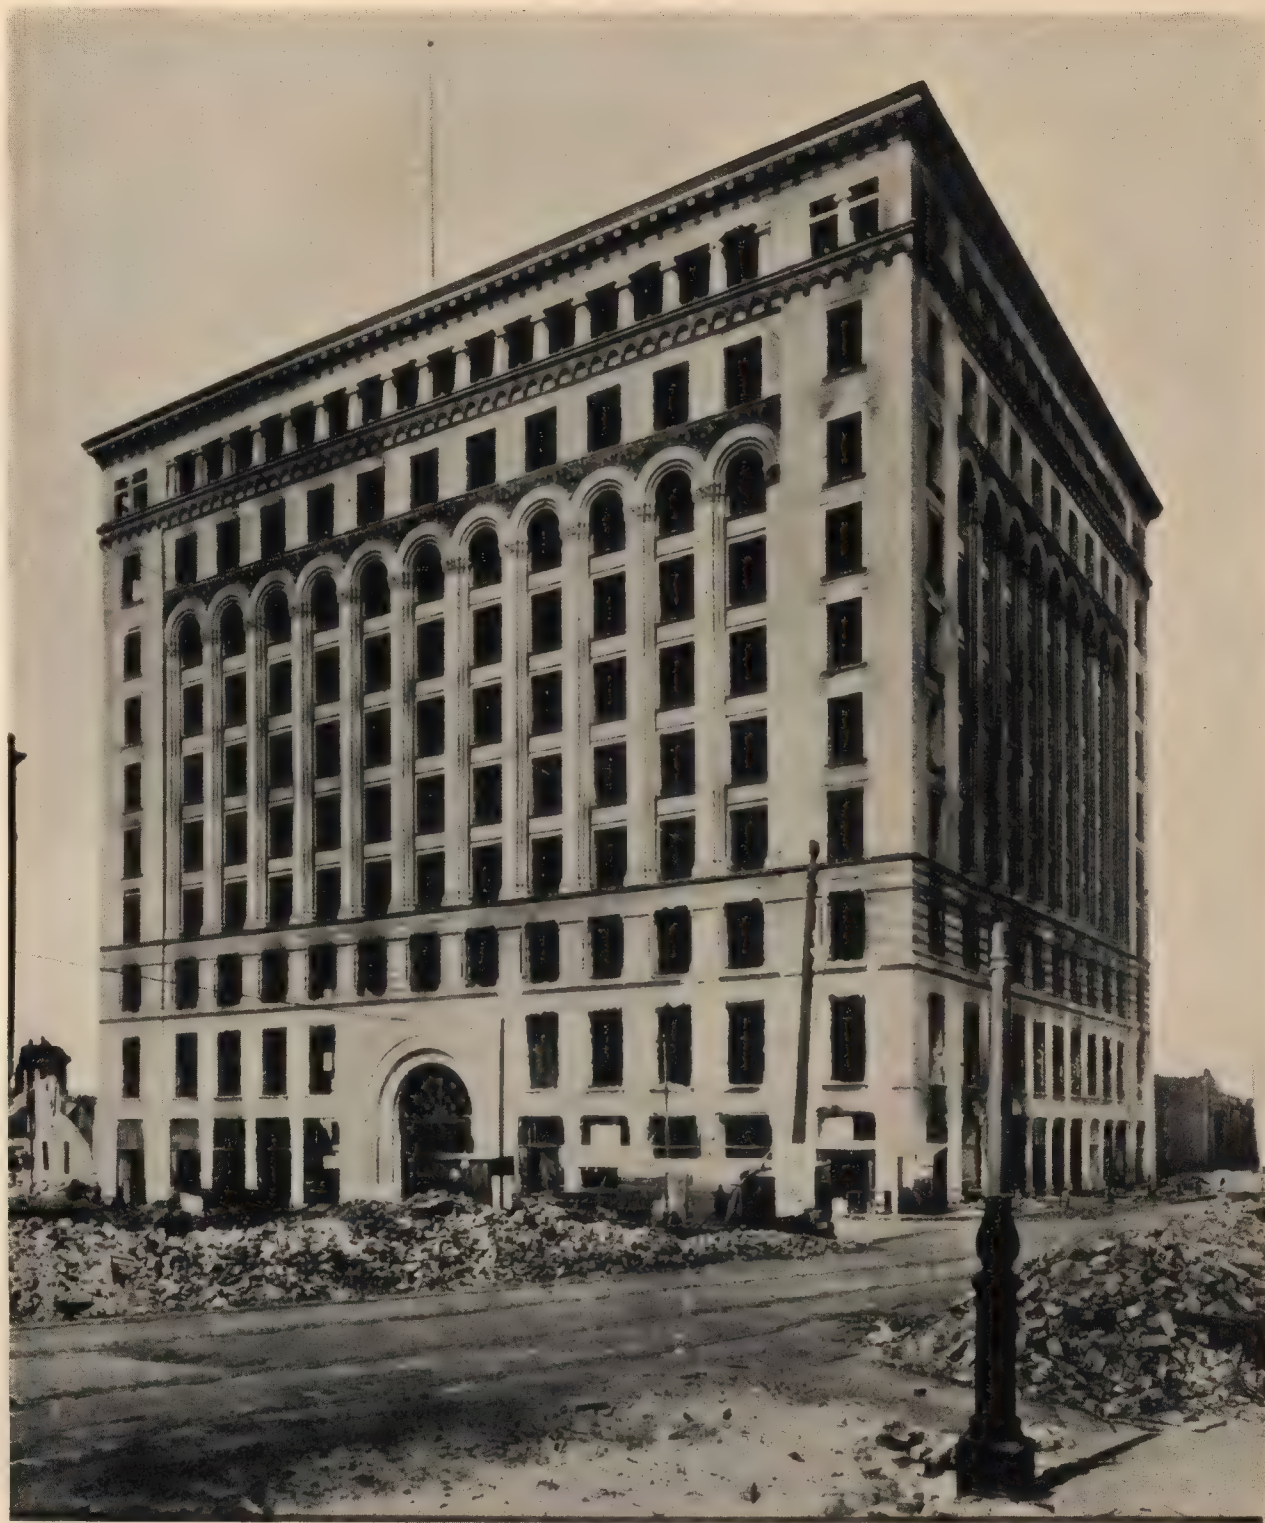
No. 8—Mills Building, 220 Montgomery Street. Brick walls, interior steel frame. Interior was badly damaged by fire. In use 1929.

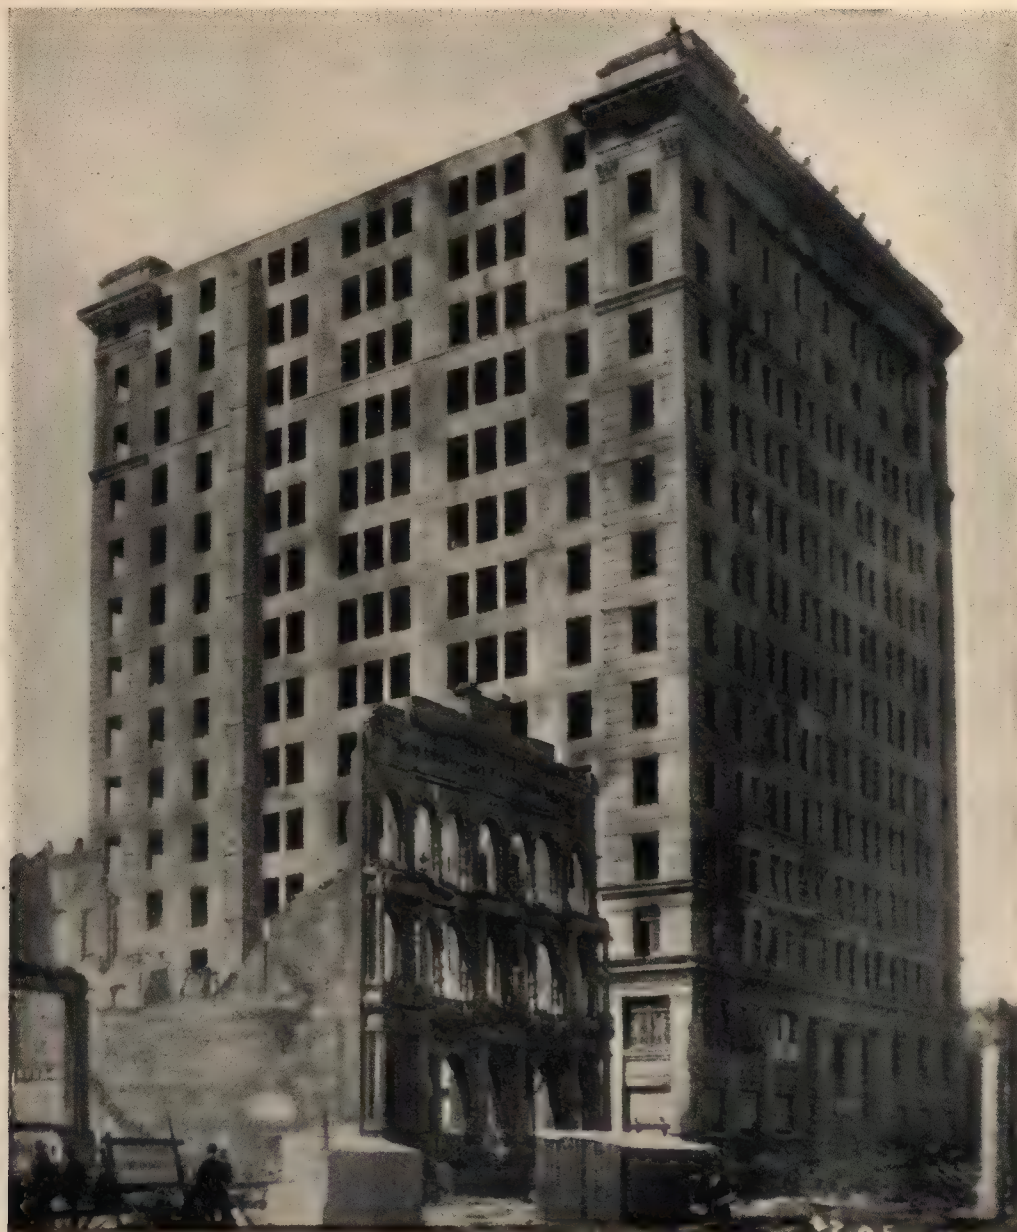
No 9—*Merchants Exchange Building, 365 California Street, showing structural condition unaffected by earthquake. In use 1929.*

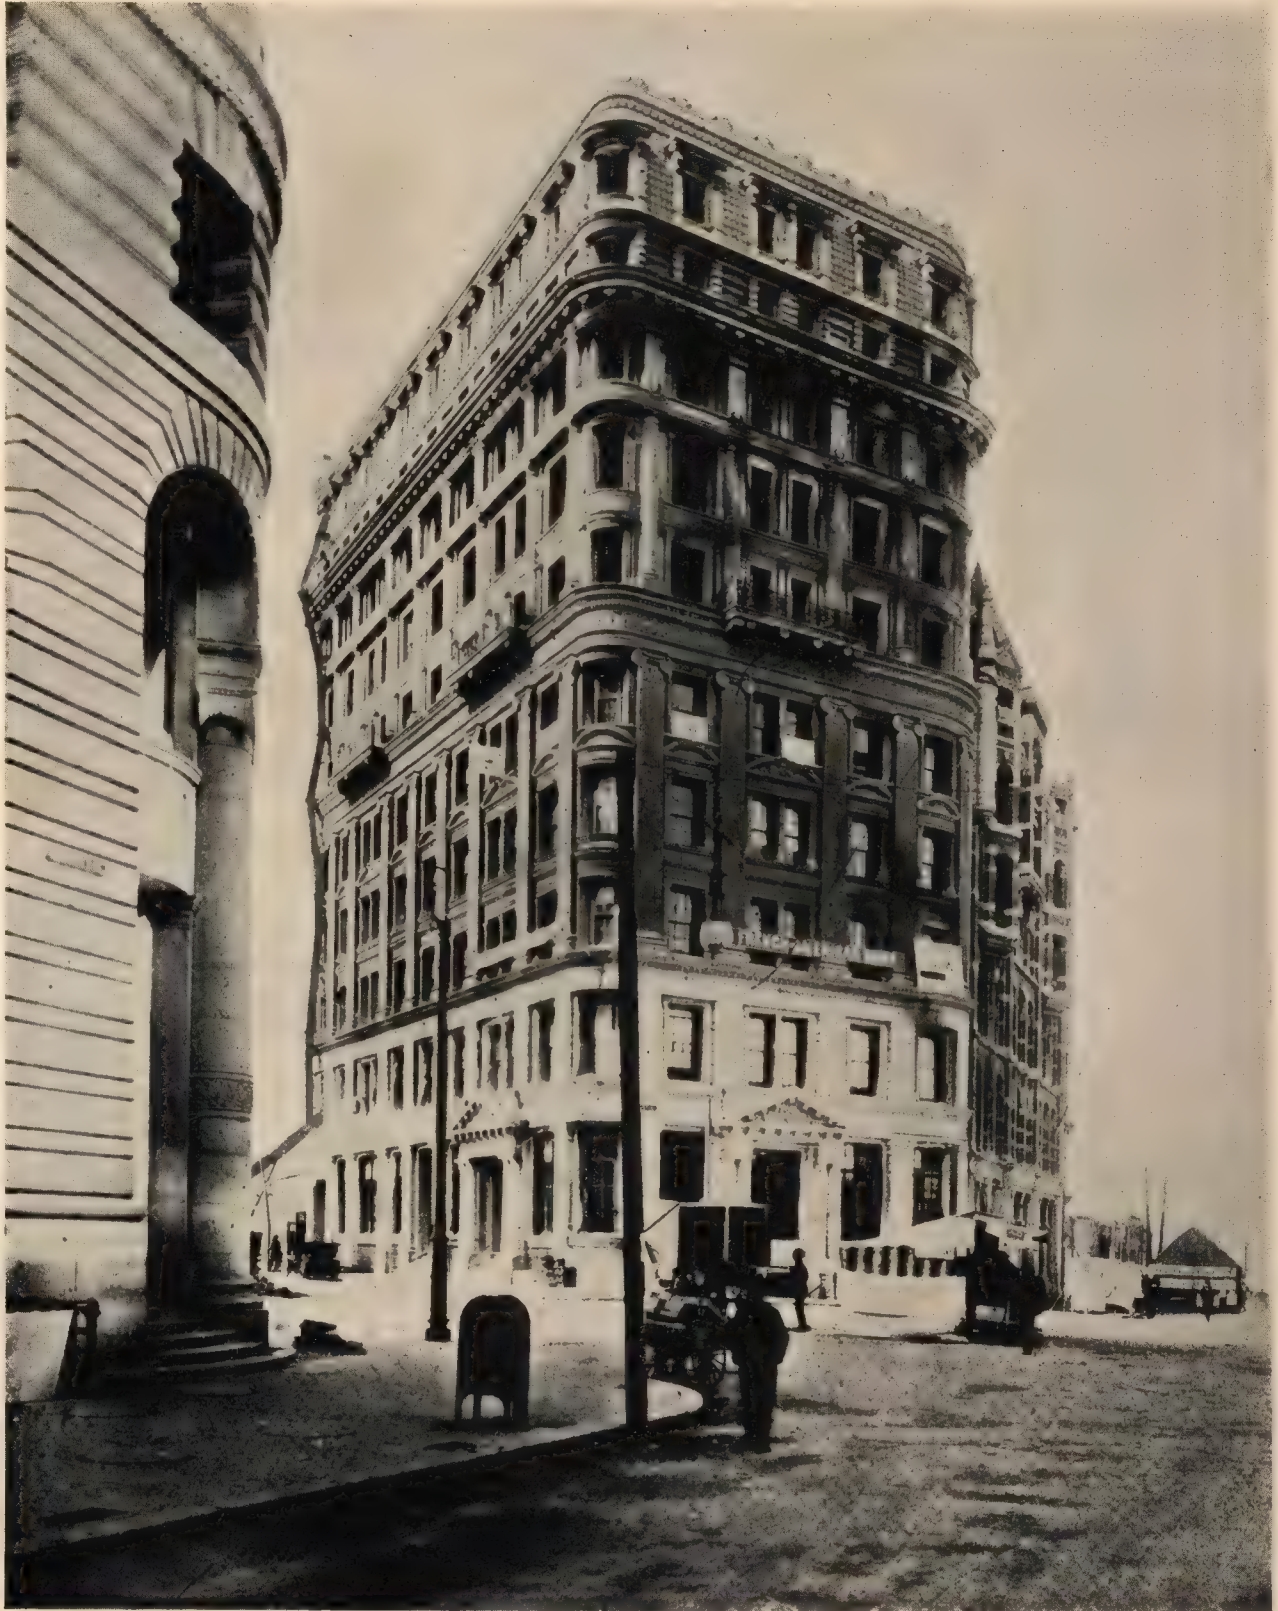
No. 10—Wells Fargo National Bank, Market and Post Streets. Interior steel frame, brick and terra cotta walls showed their resistance in spite of poor sub-soil conditions and heavy over-hanging cornices. In use 1929.

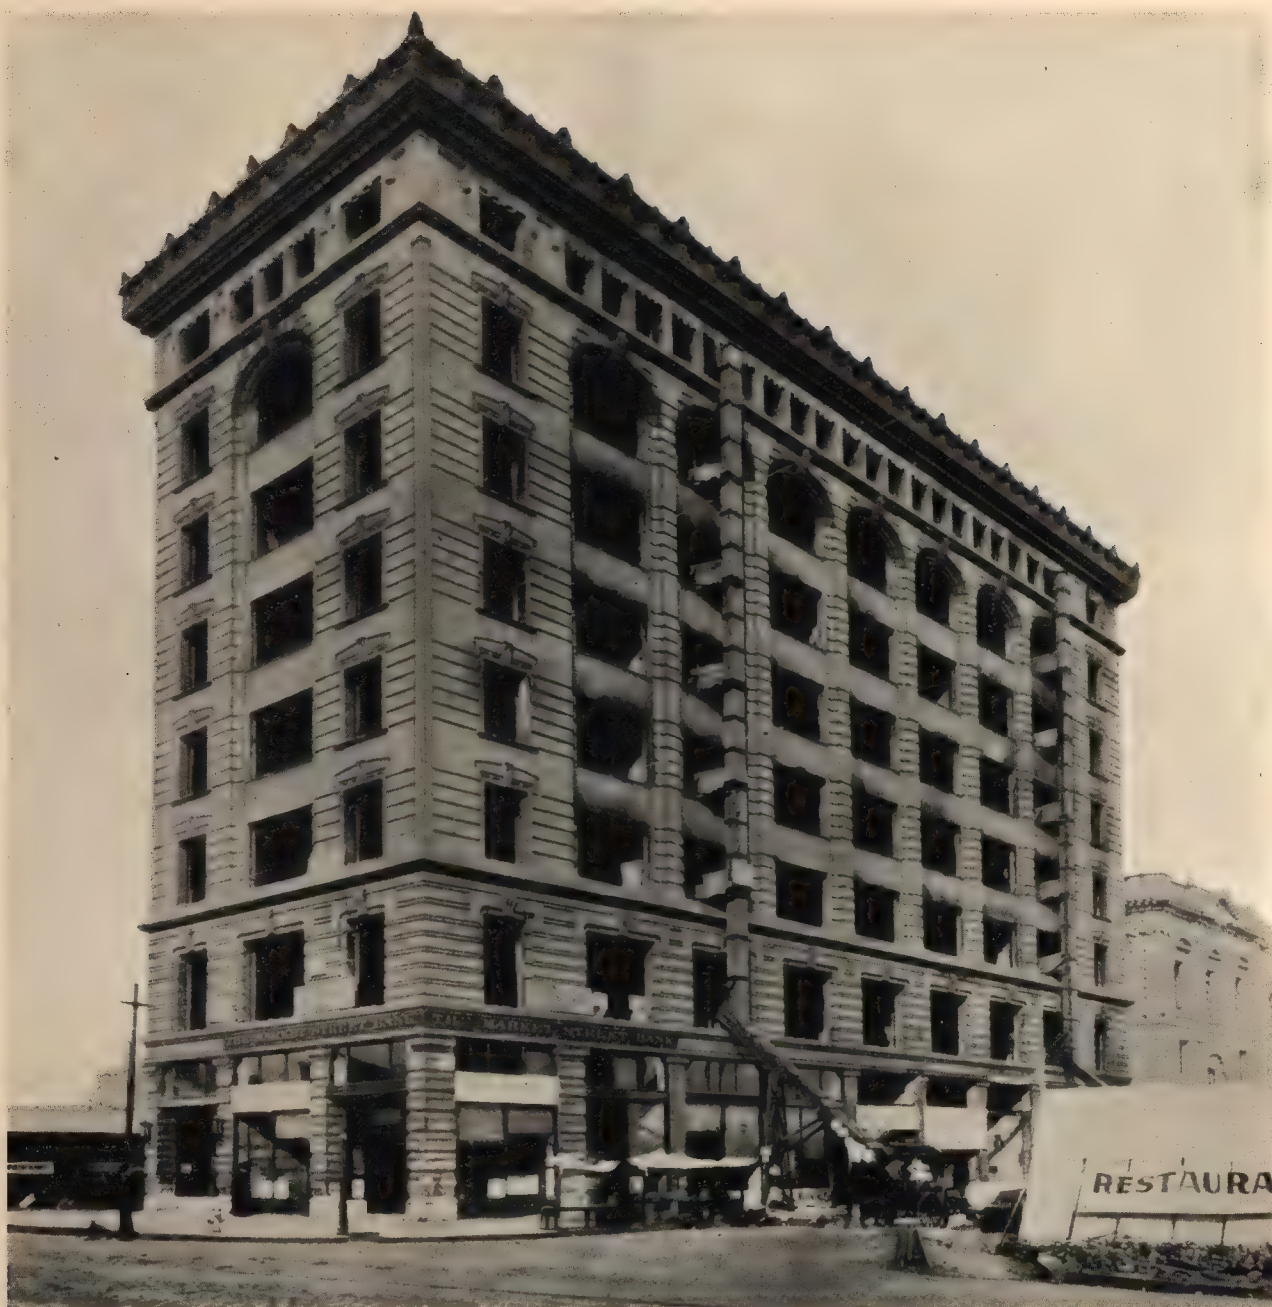
No. 11—Grant Building, 1095 Market Street, showing sound structural condition in spite of large window spaces. Interior was destroyed by fire. In use 1929.

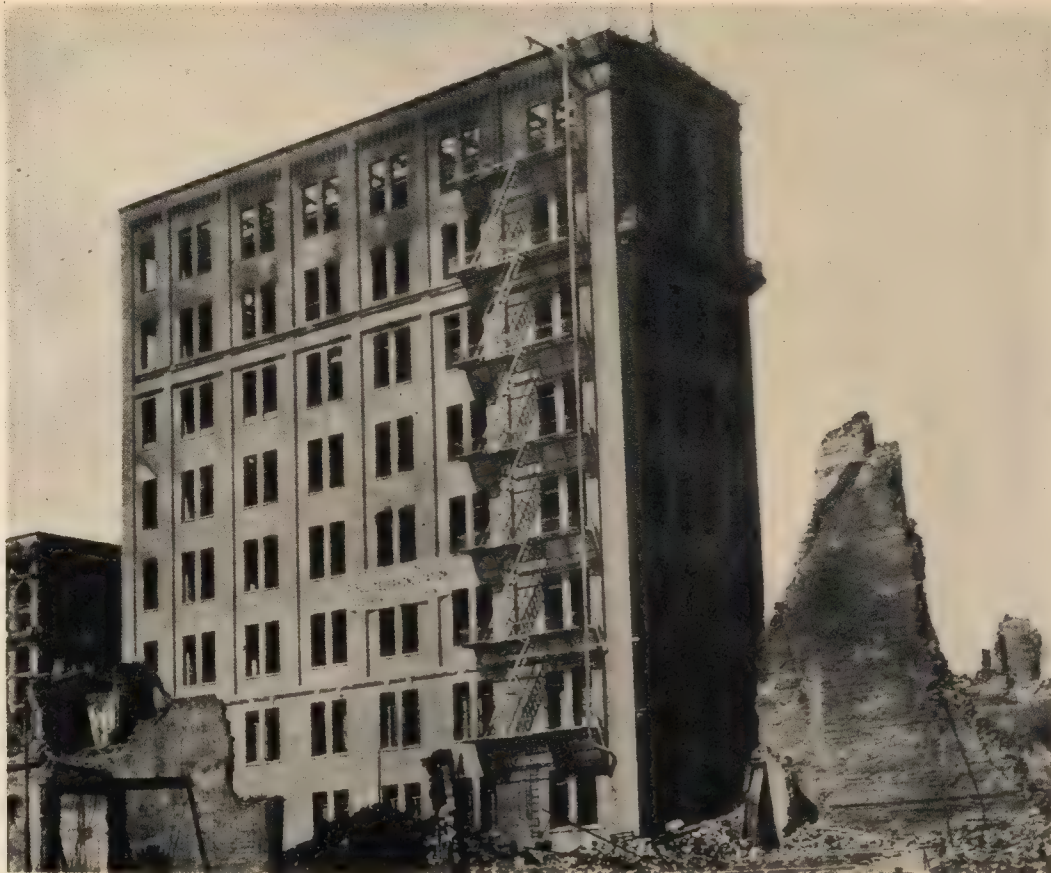
No. 11a—Pacific States Telephone-Telegraph Company's main office. Brick bearing wall building undamaged by earthquake. As a result of their experience in San Francisco the telephone company has continued to build regularly brick wall buildings. In use 1929.

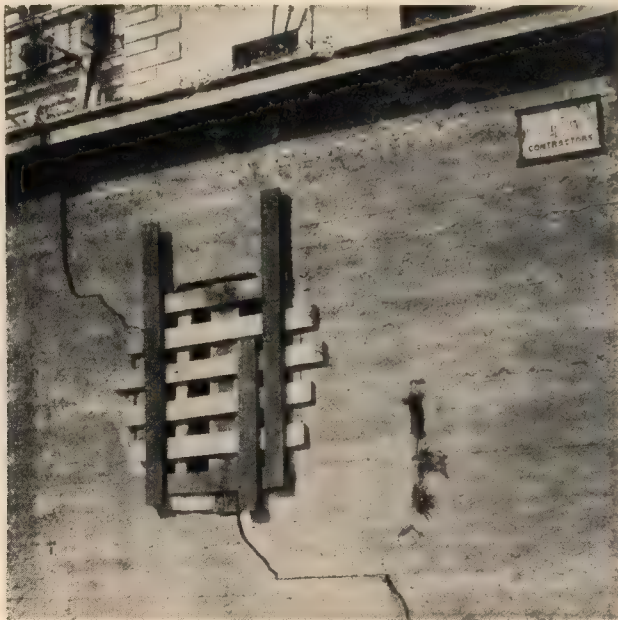
No. 12—Fairmont Hotel, showing cracks in reinforced concrete first story walls, 26" thick.

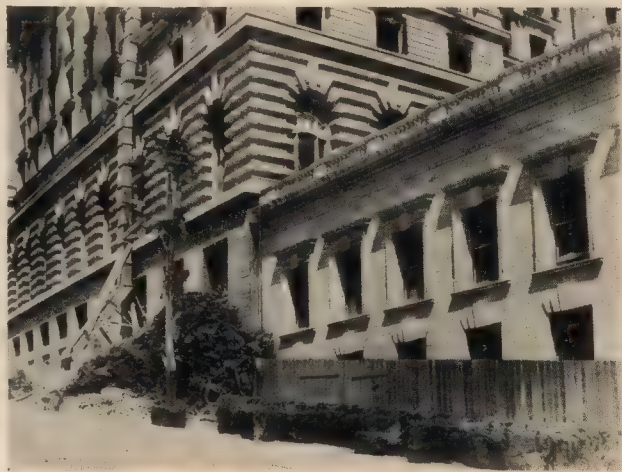
No 12a—Portion of Fairmont Hotel, California and Powell Streets, after fire. Steel frame, brick filler walls, stone facing, concrete walls in lower story, metal lath partitions. Note pile of metal lath being torn out and compare with photograph No. 12, showing cracks in reinforced concrete.

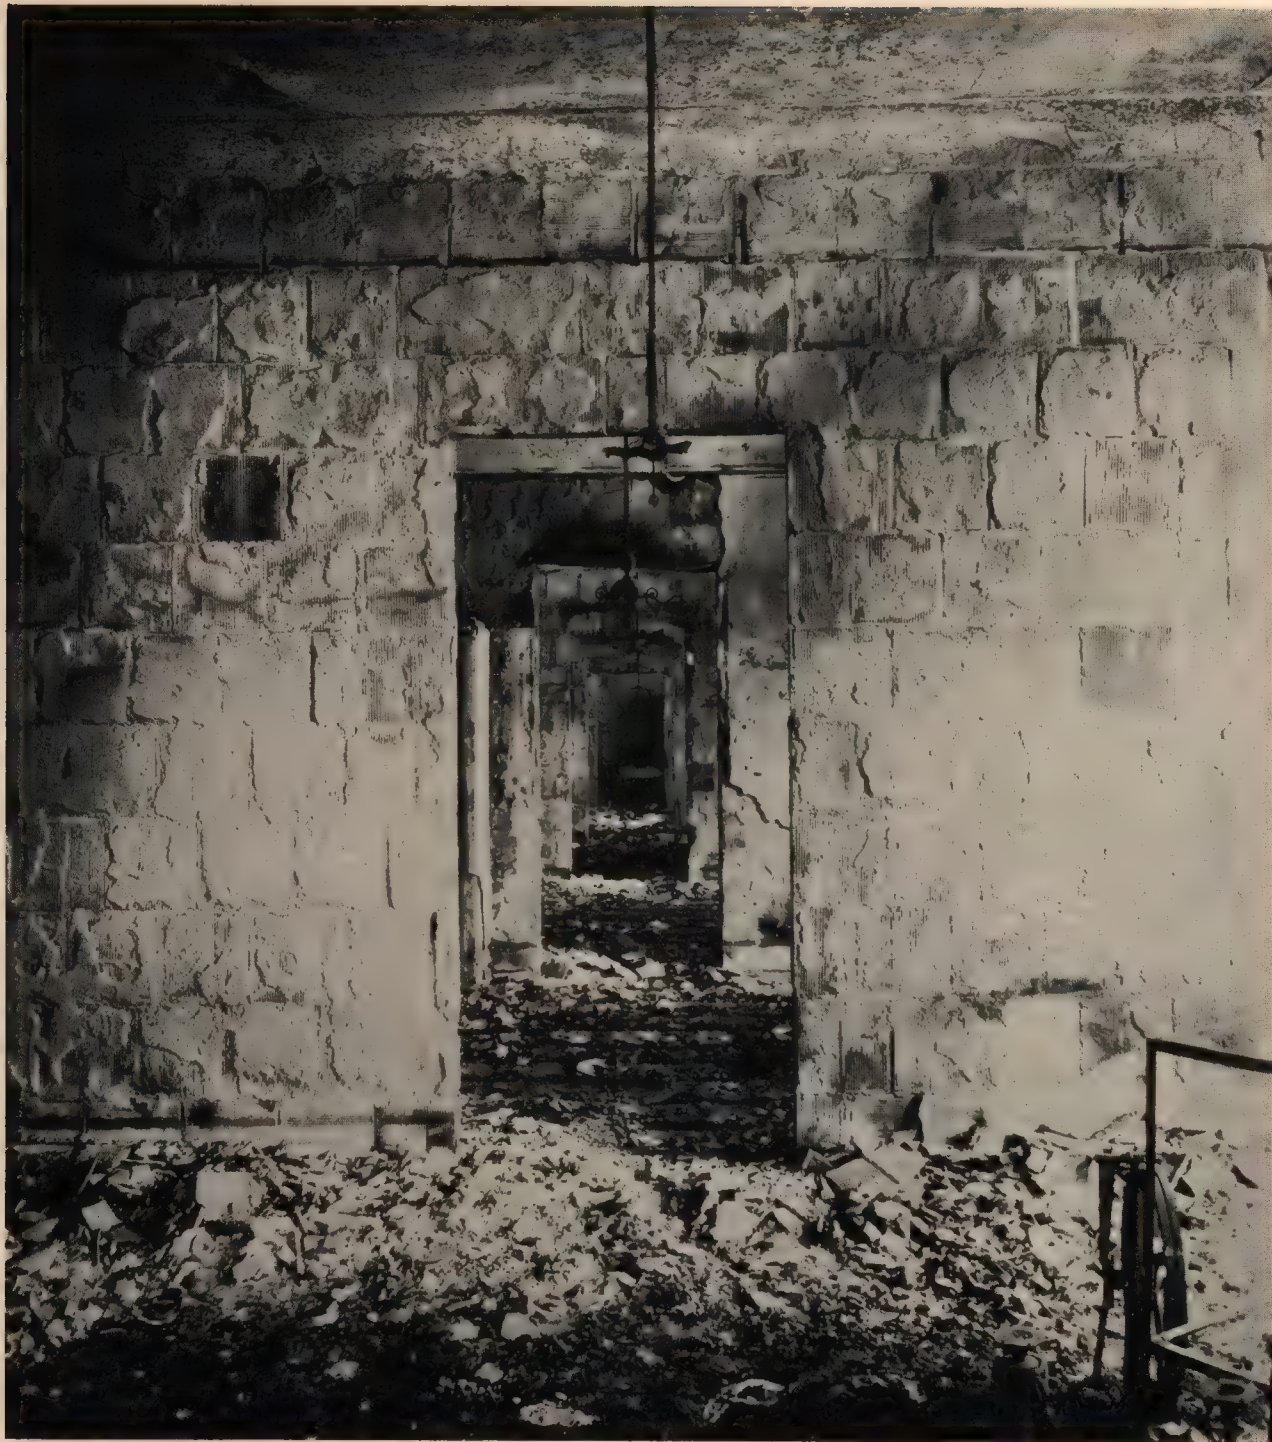
No. 14—Hollow tile partitions in earthquake and fire. A view in the Spring Valley Water Company's building (brick bearing wall). The intensity of the heat can be noted from the destruction of office furniture in the right hand corner. Tile in perfect condition from earthquake, plaster destroyed by fire.

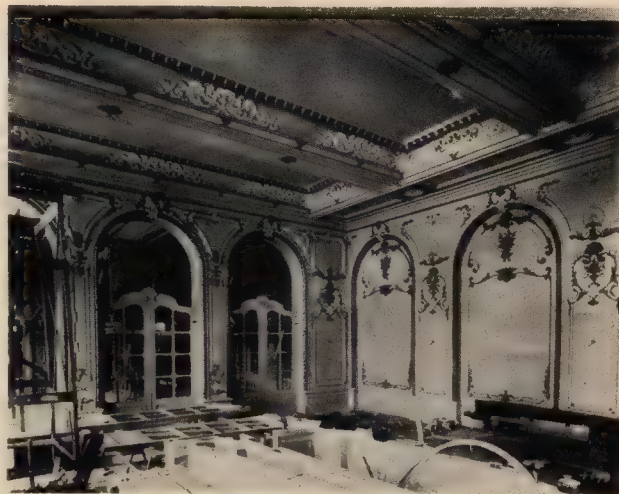
No. 13—A room on the dining room floor, Fairmont Hotel. This had never been occupied and the decorators were at work at the time of the disaster. Note unharmed condition of walls and decorations with the exception of a small break in plaster in upper right corner. This was a steel frame, brick filler wall building.

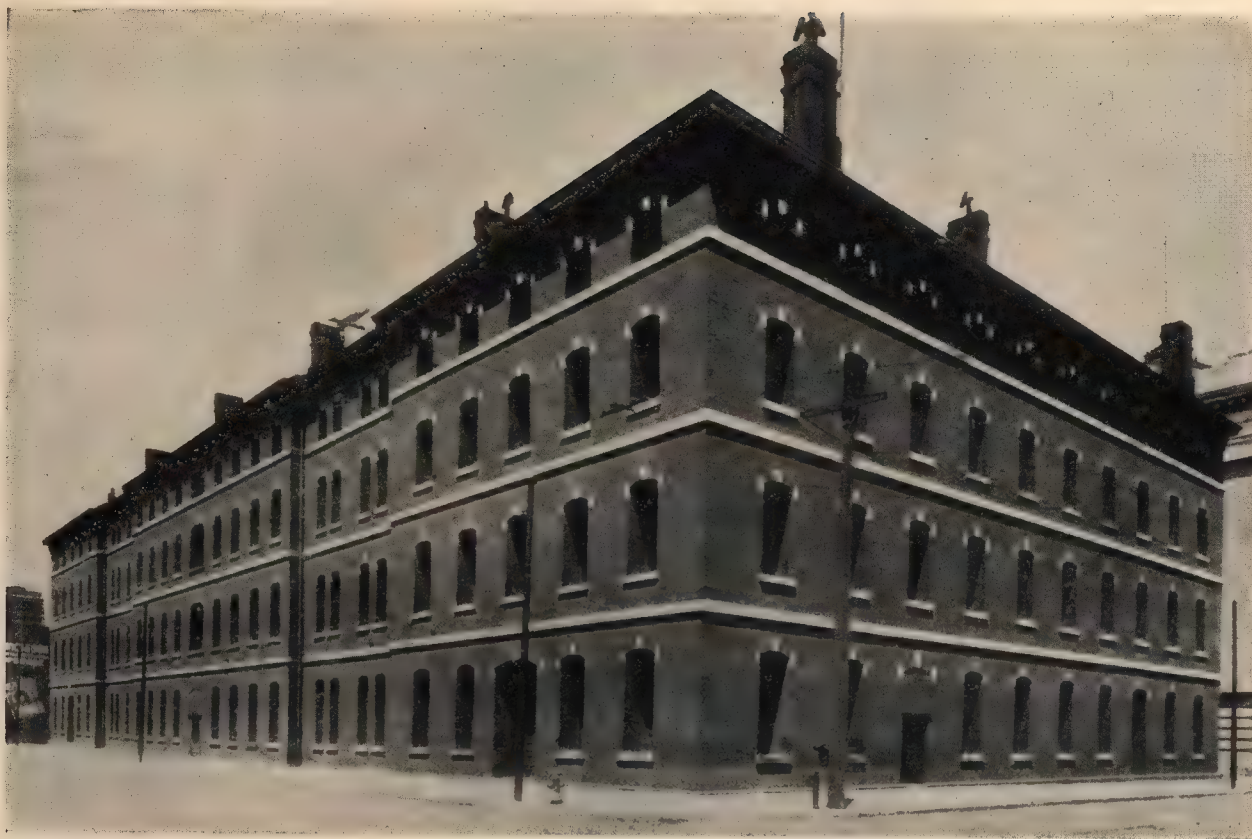
No. 15—Appraisers Stores. A four-story structure at the corner of Sansome and Jackson undamaged by earthquake. In use 1929.

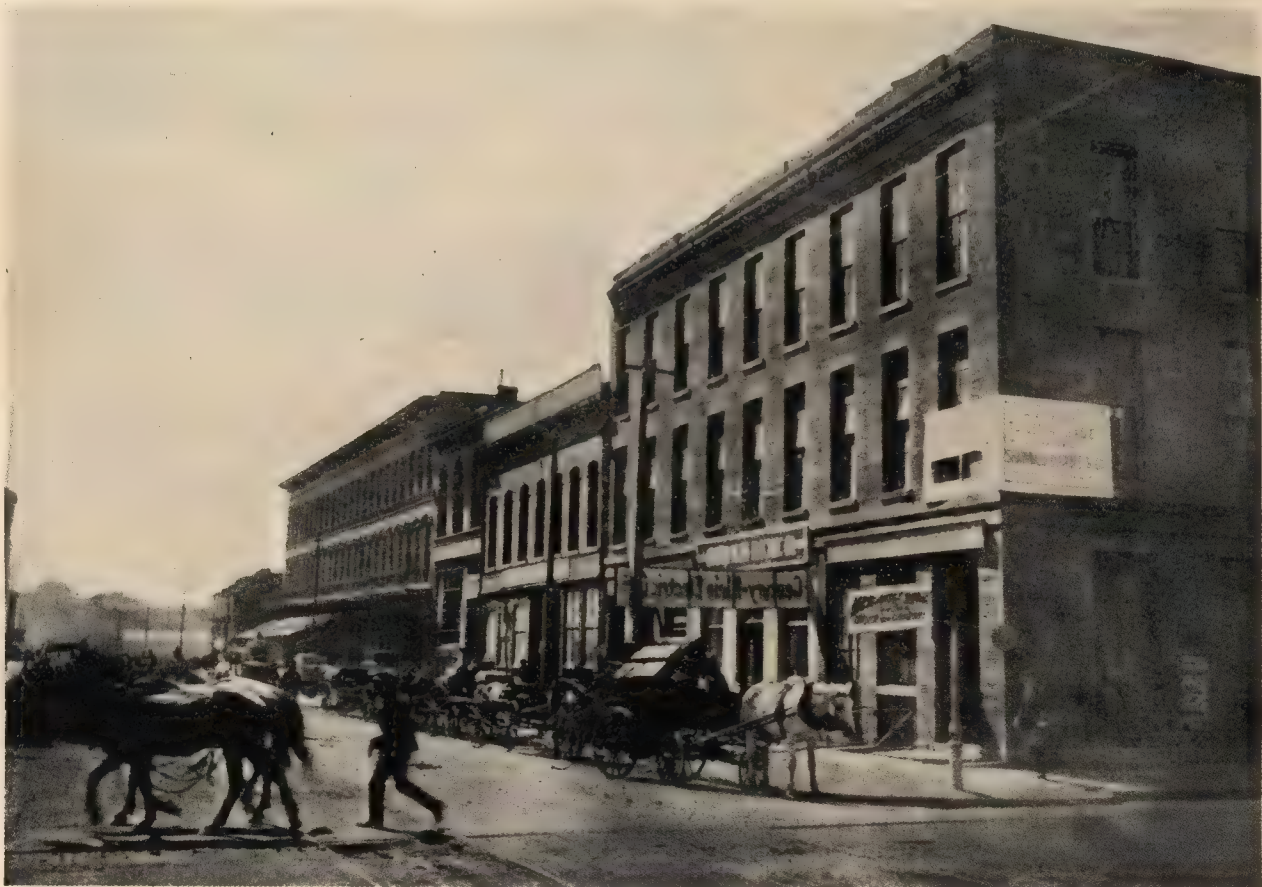
No. 18—Sansome and Jackson Streets immediately after the earthquake. All brick bearing wall buildings not burned by fire and practically all in the same condition 1929.

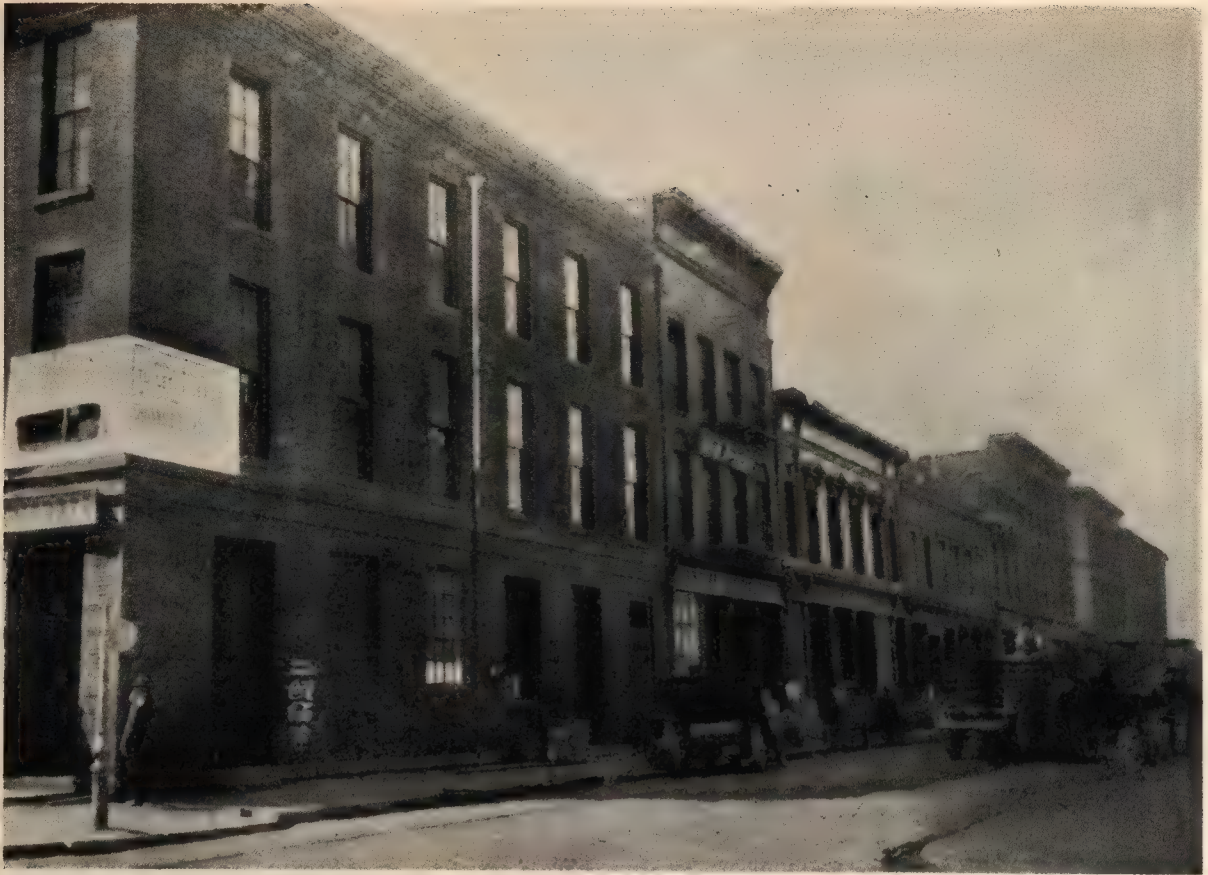
No. 19—Southwest corner of Jackson and Sansome looking down Jackson. These brick bearing wall buildings undamaged by earthquake, not touched by fire and still in use 1929. They were erected in the early 60's.

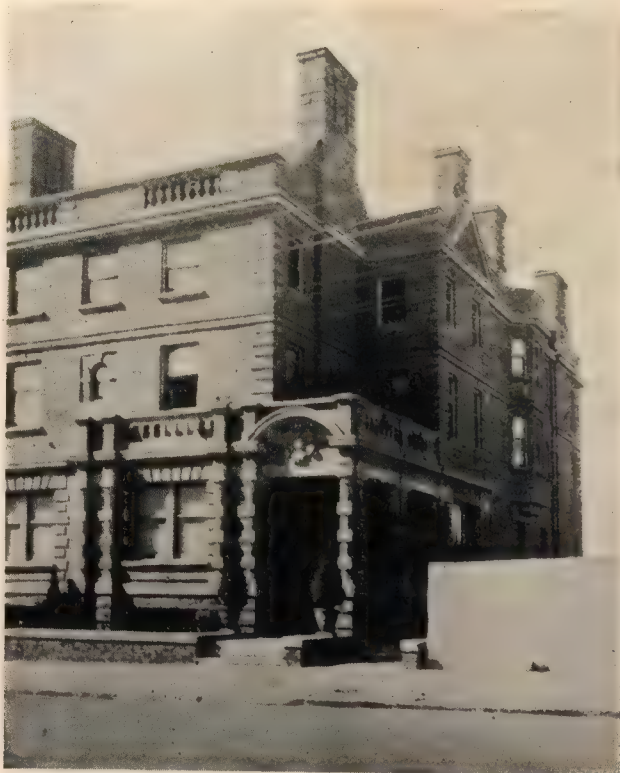
No. 22—Brick residence unharmed by earthquake.

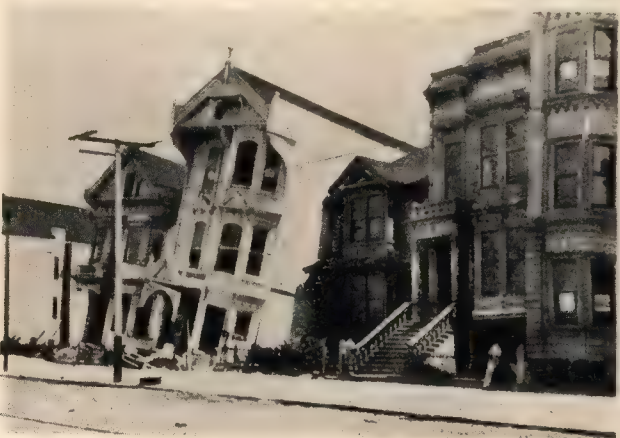
No. 23—Frame buildings are not immune from earthquake damage. In addition to collapse of buildings at the left, notice buckling of buildings in right corner.

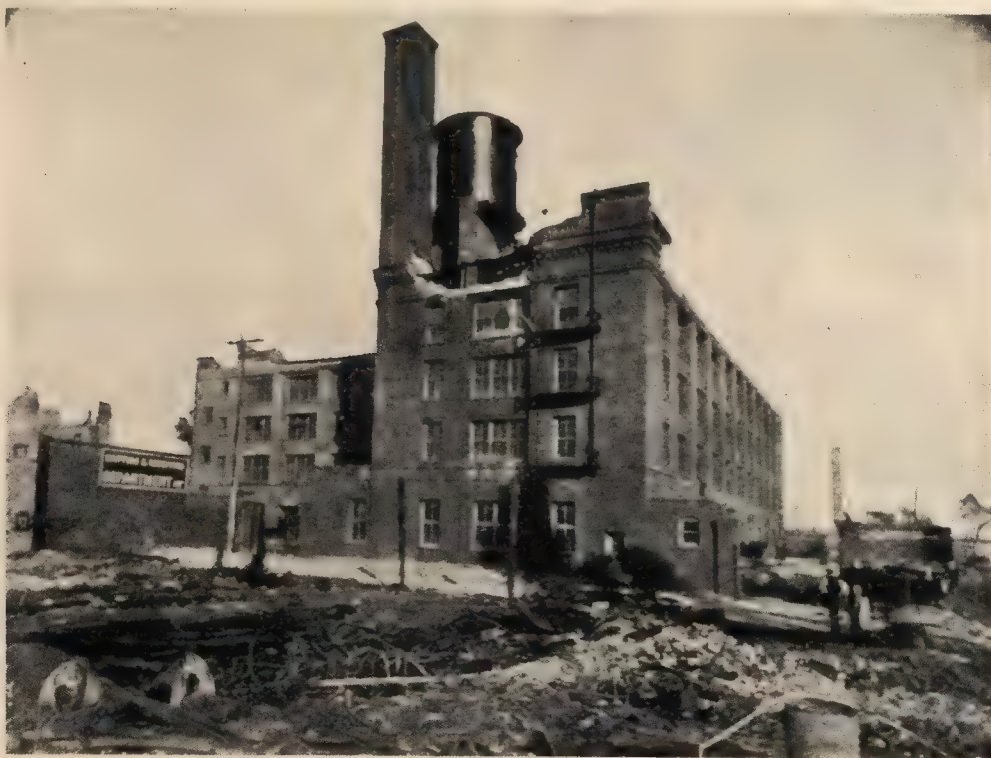
No. 28—Brick bearing wall building of California Electrical Works preserved through fire by private water supply system. No structural damage except in walls composing roof tank pedestal.
